**Thoughts on the Grenfell Tower Fire:  
When the Colour of Fire is Grey**

**Prof Ed Galea  
Director Fire Safety Engineering Group  
University of Greenwich**

**27/07/17**

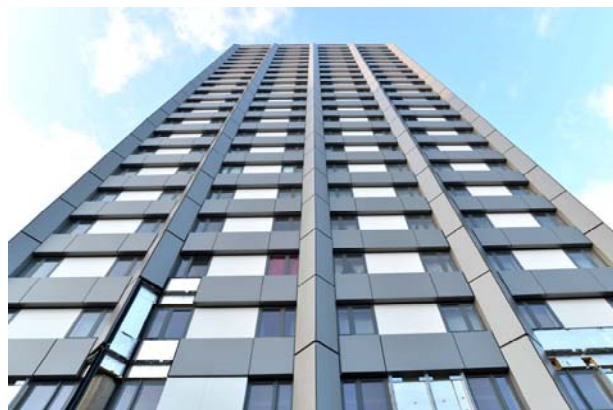
Figure 1: Grenfell Tower showing five vertical columns on one building face extending the entire height of the building.

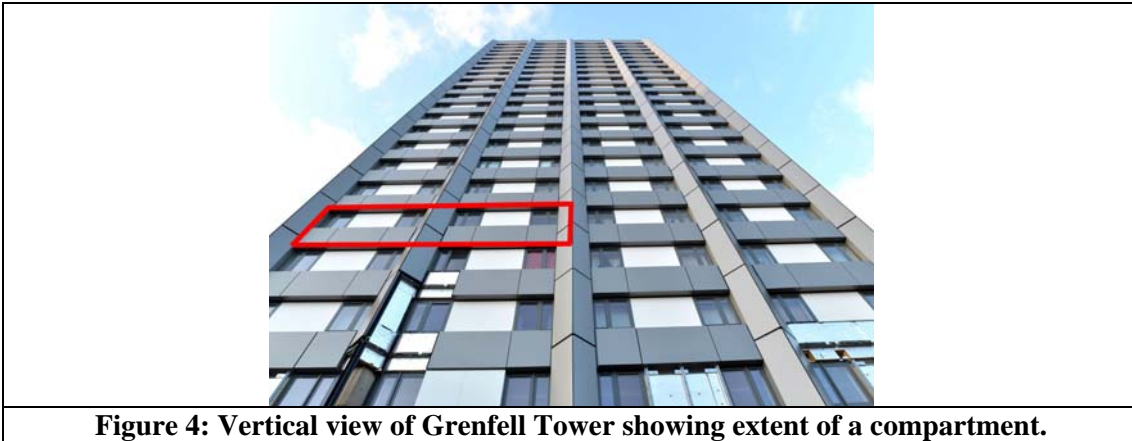
The vertical and horizontal extent of a typical two-bedroom compartment is also shown in elevation view in figure 4. Note that the compartment would extend around the corner of the building as depicted in figure 3.

**Figure 4: Vertical view of Grenfell Tower showing extent of a compartment.**

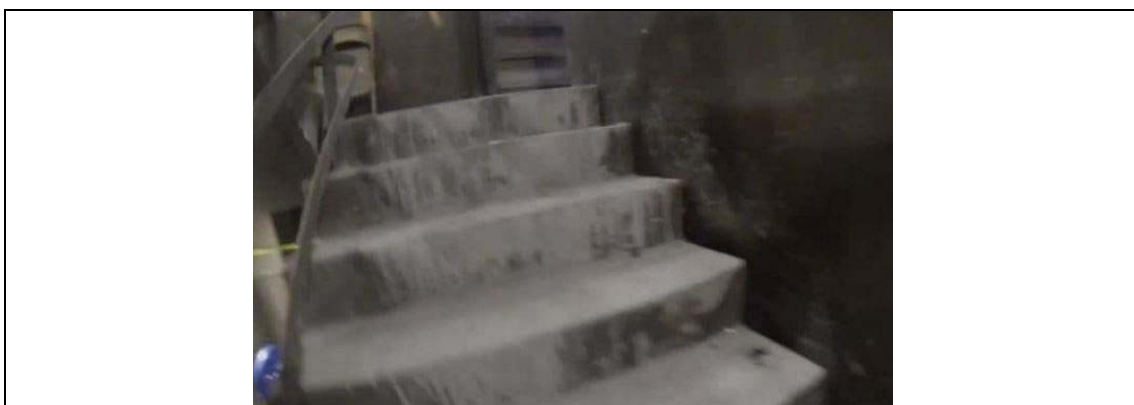
**“The stairwell is not wide. Just over 1m (3ft)<sup>14</sup>”**

This is sufficiently wide to accommodate only a single person per stair tread (see Figure 5). It is also reported that while the building had local fire alarms – within each flat – there were no communal alarms, or at least no working communal alarms. So, while a resident could be alerted about a fire in their own flat, they had no idea if there was a fire in the communal areas which could potentially threaten their safety.

**Figure 5: Only means of escape from Grenfell Tower**
